## CALL FOR INSPECTION

### of Lyon OBELISK & TRIBUS Leg Restraint Strap

19<sup>th</sup> December 2024

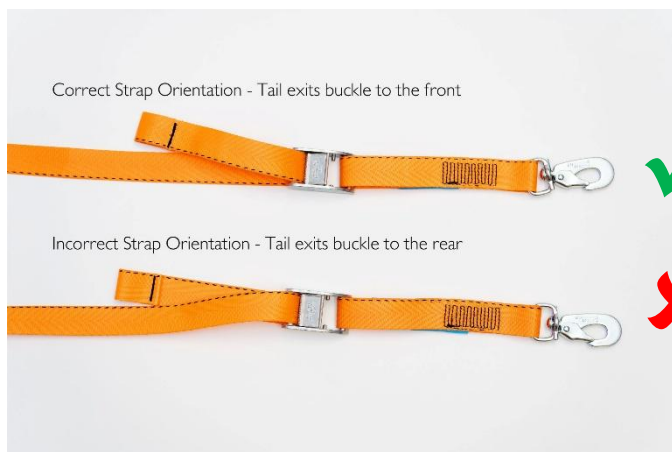
During production, the adjustment buckle has been sewn onto the webbing incorrectly. When incorrectly configured, the adjustment buckle does not tighten and lock in position. The webbing slips through the buckle.

Correct Strap Orientation - Tail exits buckle to the front

Incorrect Strap Orientation - Tail exits buckle to the rear

If you have a strap affected by the incorrect configuration, we ask you to return the incorrect strap so we can supply you with a correct Leg Restraint Strap.

Please email [helpdesk@lyon.co.uk](mailto:helpdesk@lyon.co.uk) if you have an affected Leg Restraint Strap and we will supply a free shipping label to return. On receipt, we will issue a replacement strap. Please also include a return address to send the replacement Leg Restraint Strap to.
